**ANNUAL SITE MONITORING REPORT 2011  
FORMER HANCOCK COUNTRY HAMS  
3484 NC HIGHWAY 22 NORTH  
FRANKLINVILLE, NORTH CAROLINA**

**Reference: Annual Site Monitoring Report 2011  
Former Hancock Country Hams  
3484 NC Highway 22 North  
Franklinville, North Carolina  
Environmental Alliance, Inc. Project # 2719A**

## HANCOCK COUNTRY HAMS SITE MONITORING REPORT

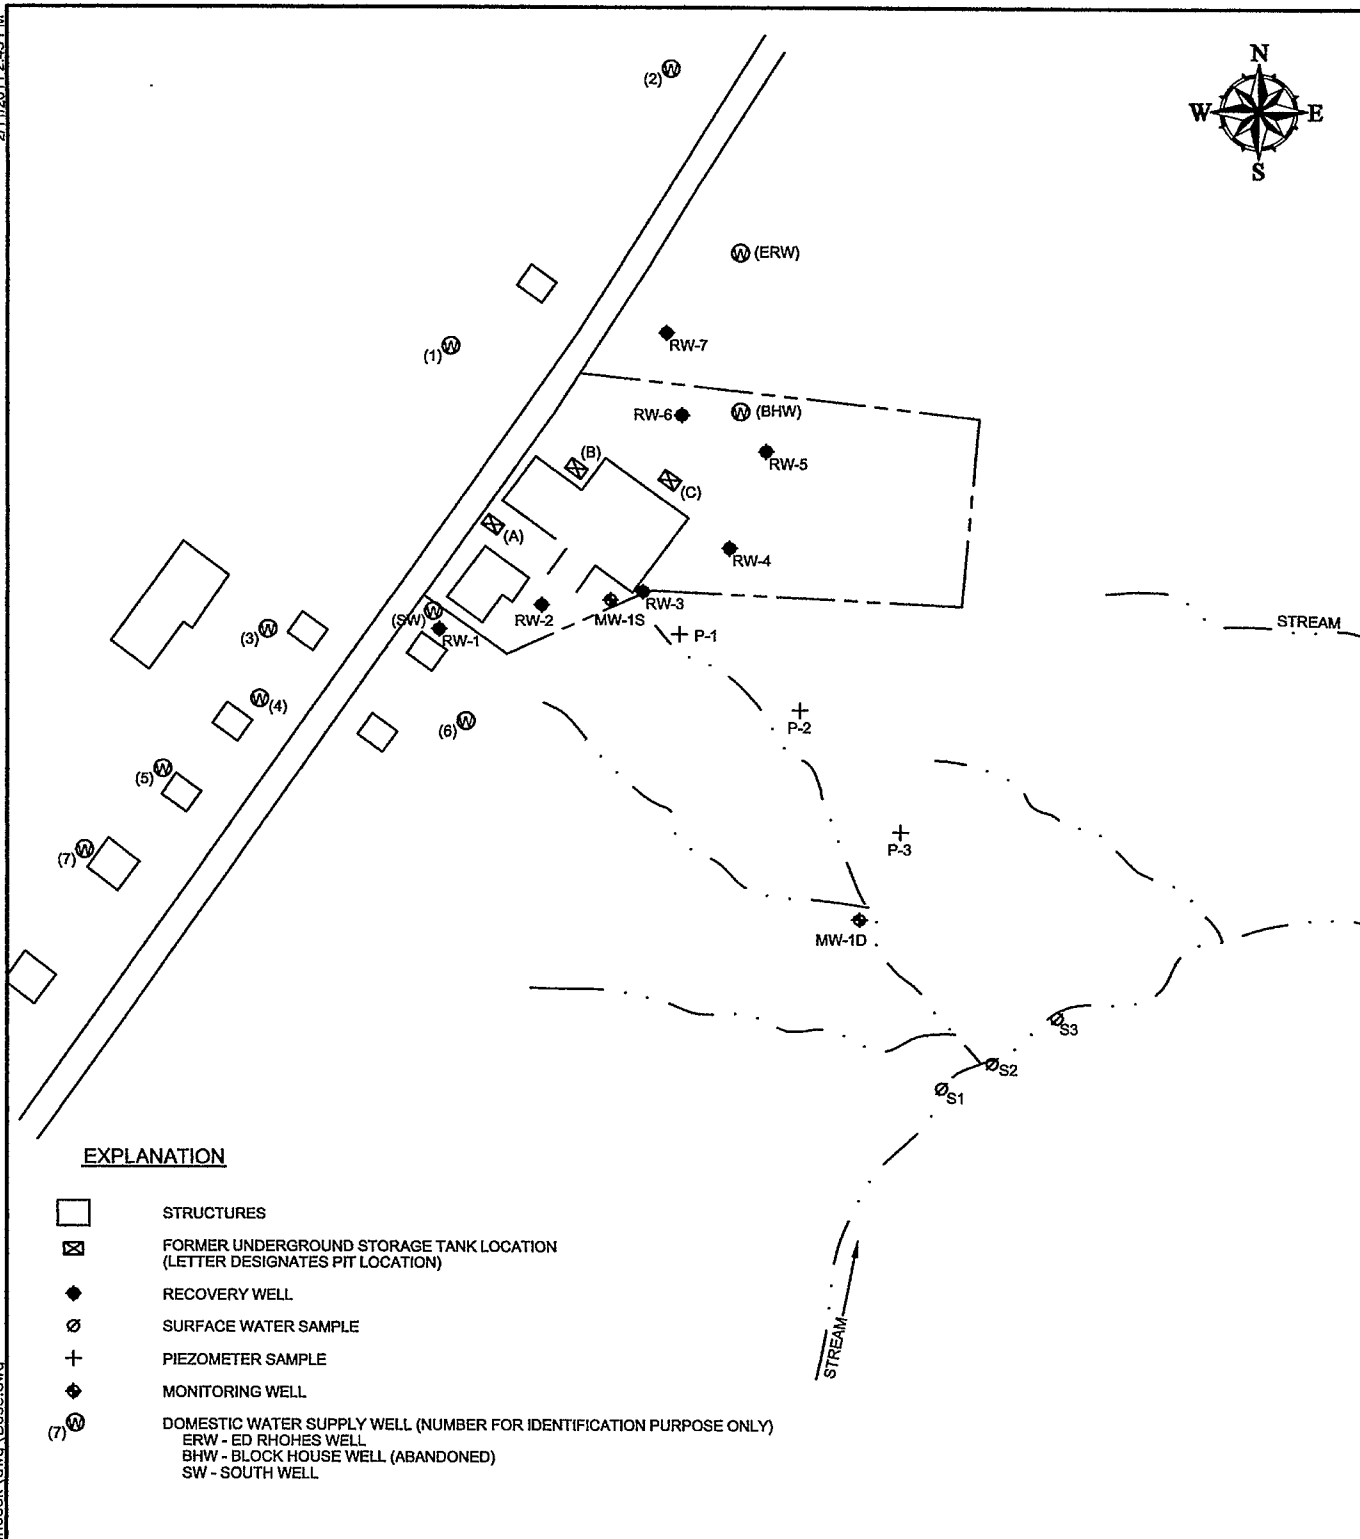
DESIGNED BY: —	DRAWN BY: AGG	UPDATED BY: —	FIGURE NO:  <b>2</b>
APPROVED BY: JSE	PROJECT NO. 2719	DATE: 2/11/2011

## SITE MAP

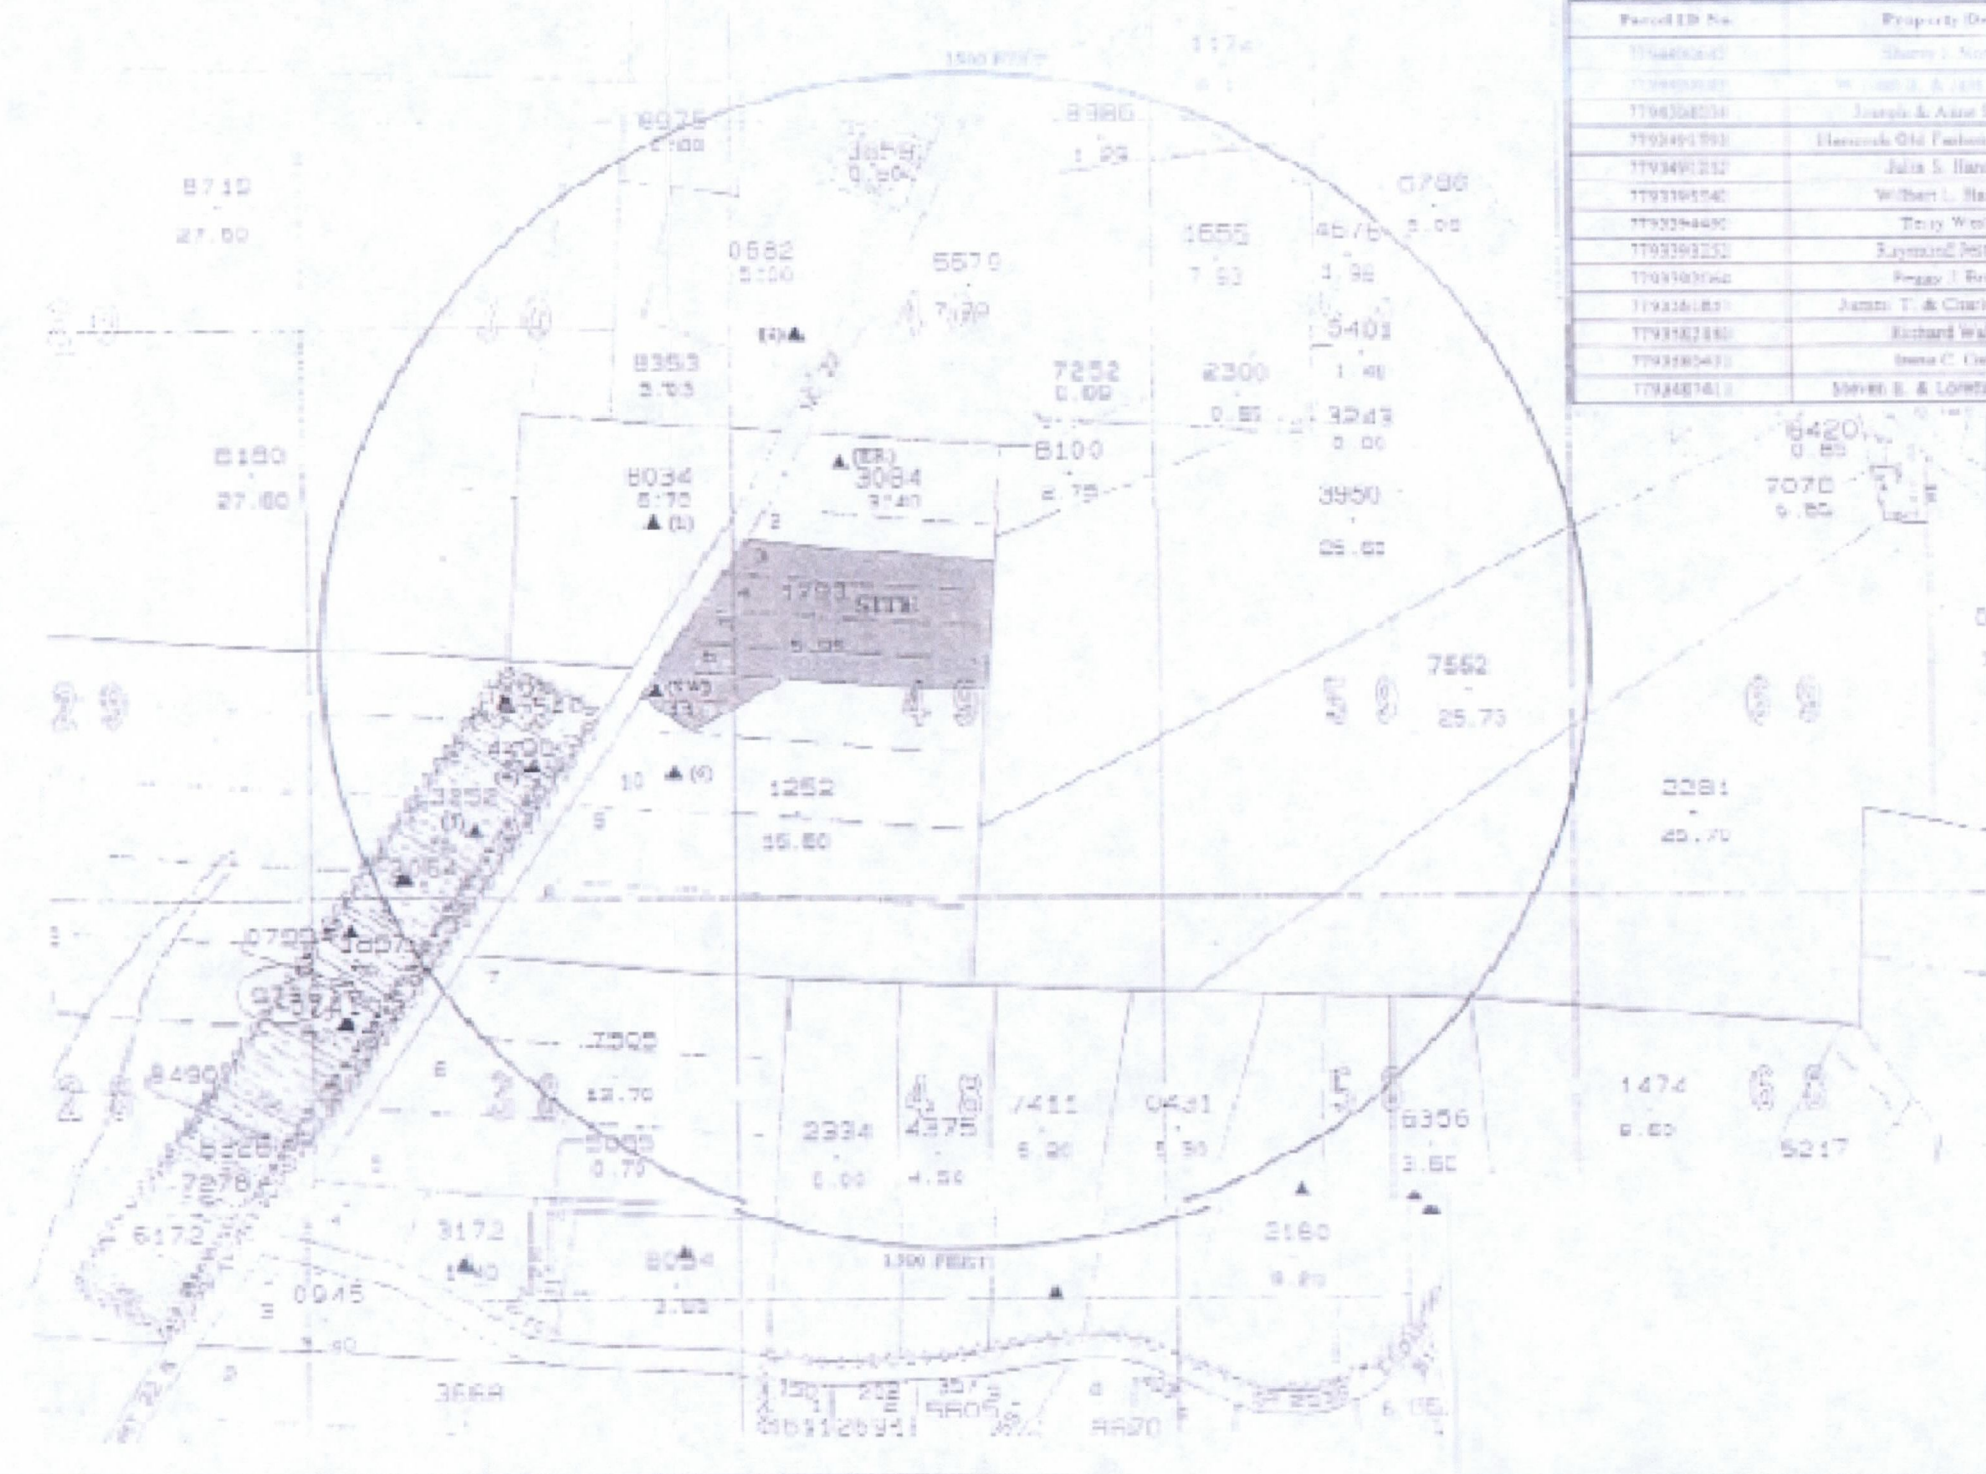
SCALE: 1" = 400'	DATE: 1/15/09	APPROVED BY: JSE	SOURCE: BPA ENVIRONMENTAL & ENGINEERING, INC. MARCH 23, 1998 REPORT
HANCOCK COUNTRY HAMS 3484 NC HIGHWAY 22 FRANKLINVILLE, NORTH CAROLINA			
WATER SUPPLY WELLS WITHIN 1500 FEET OF THE SITE			FIGURE 3

A well survey of the area in October 1996 determined that there are approximately nine water supply wells within 1,500 feet of the site (Figure 3) and another seven wells within 1,750 feet of the site. Five of these wells are separated from the site by a stream valley (Figure 4). The names and addresses of water well users within 1,500 feet of the site are shown in Table 1. During the fall of 2007, a public water main was installed along NC Highway 22 to supply a proposed school north of the site. To date, all of the residences except for the Norman residence (located up- and cross-gradient of the chloride plume) have been connected to the public water system.

The owners of the properties located immediately adjacent to the site are listed in Table 2. Their locations are shown on Figure 3.

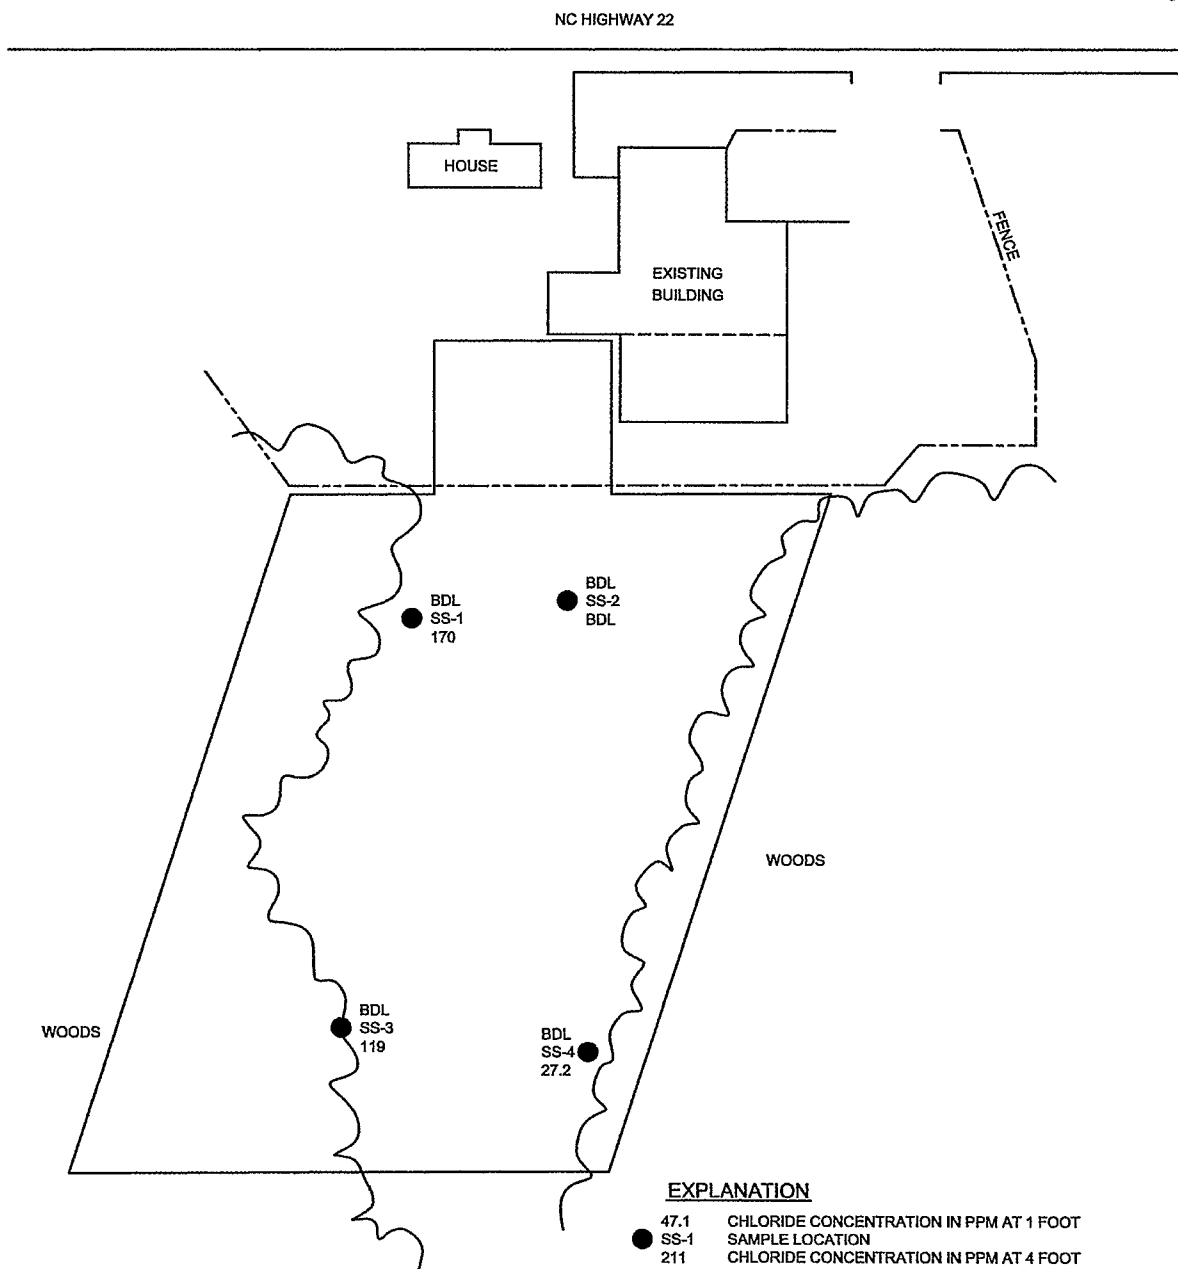
- 47.1 CHLORIDE CONCENTRATION IN PPM AT 1 FOOT
- SS-1 SAMPLE LOCATION
- 211 CHLORIDE CONCENTRATION IN PPM AT 4 FOOT
- BDL BELOW DETECTION LIMIT
- PREVIOUS SOIL SAMPLING AREA

Concentrations of chloride in the soil samples collected on January 18, 2011 were below detection limits in the 1-foot samples from SS-1, SS-2, SS-3, and SS-4. Chloride concentrations at SS-1, SS-3, and SS-4 in the 4-foot samples ranged from 27.2 mg/kg in SS-4 to 170 mg/kg in SS-1, and were all higher than in the previous soil sampling event in January 2010. Chloride concentrations at SS-2 remained consistent with the 2010 sampling event and were below detection limits in both the 1-foot and 4-foot samples. The soil sampling analytical data is summarized on Table 4, and the accompanying laboratory analyses and chain-of-custody can be found in Appendix A.

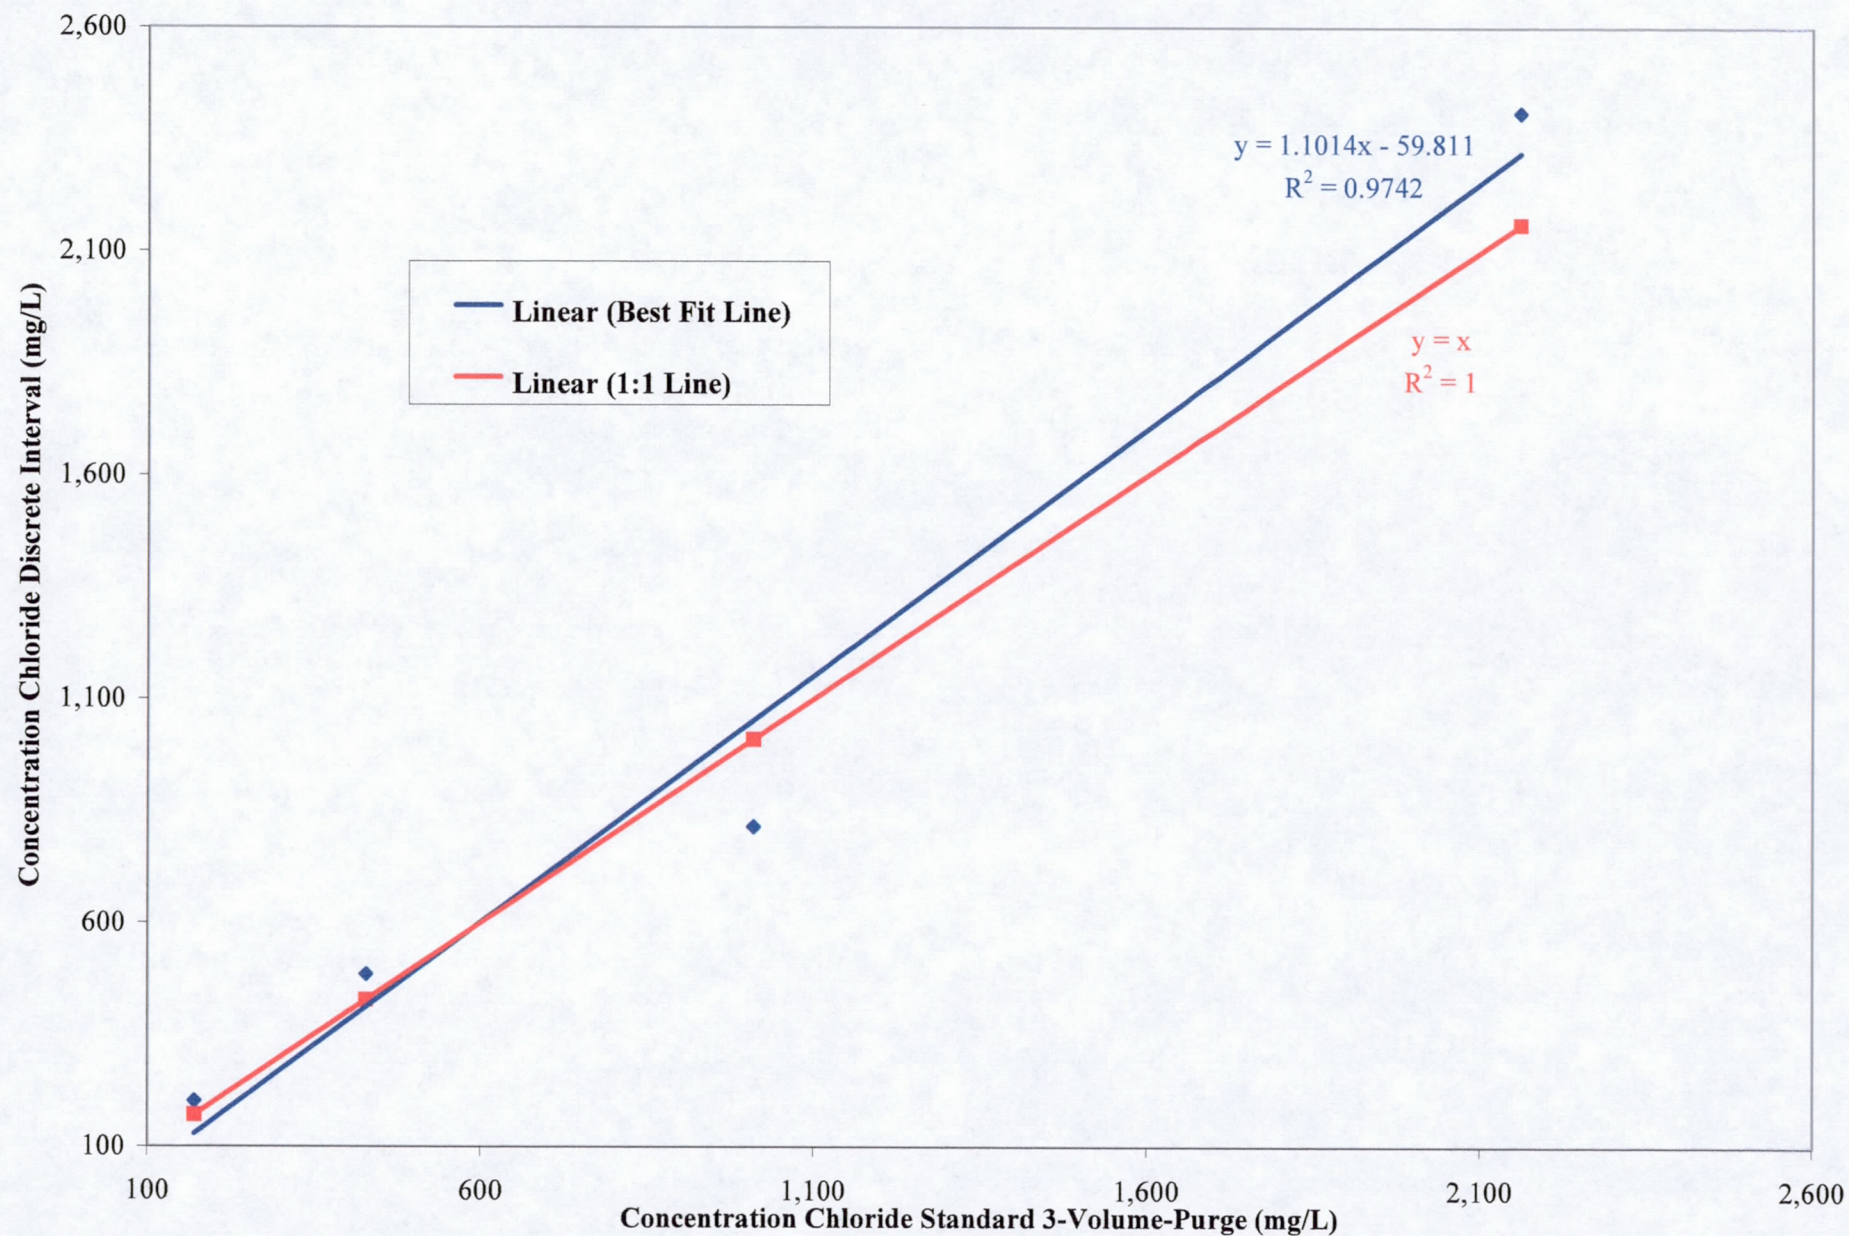
Figure 7  
Comparison of Chloride Results -  
Discrete Interval Sampling vs. Standard 3-Well-Volume-Purge  
Hancock County Hams, Franklinville, North Carolina

To graphically and quantitatively compare the discrete interval sampling results to those from the conventional three-well-volume purge, a linear regression curve (Figure 7) was created for the recovery wells that were sampled by using both methods. As shown on this graph, the results from both sampling methods show very close agreement and correlation. This correlation is further illustrated by the high R-squared value of over 97%, the best-fit line slope of 1.1 (1.0 would indicate an exact match) and low y-intercept of -59.8 mg/L (0.0 mg/L would indicate an exact match).

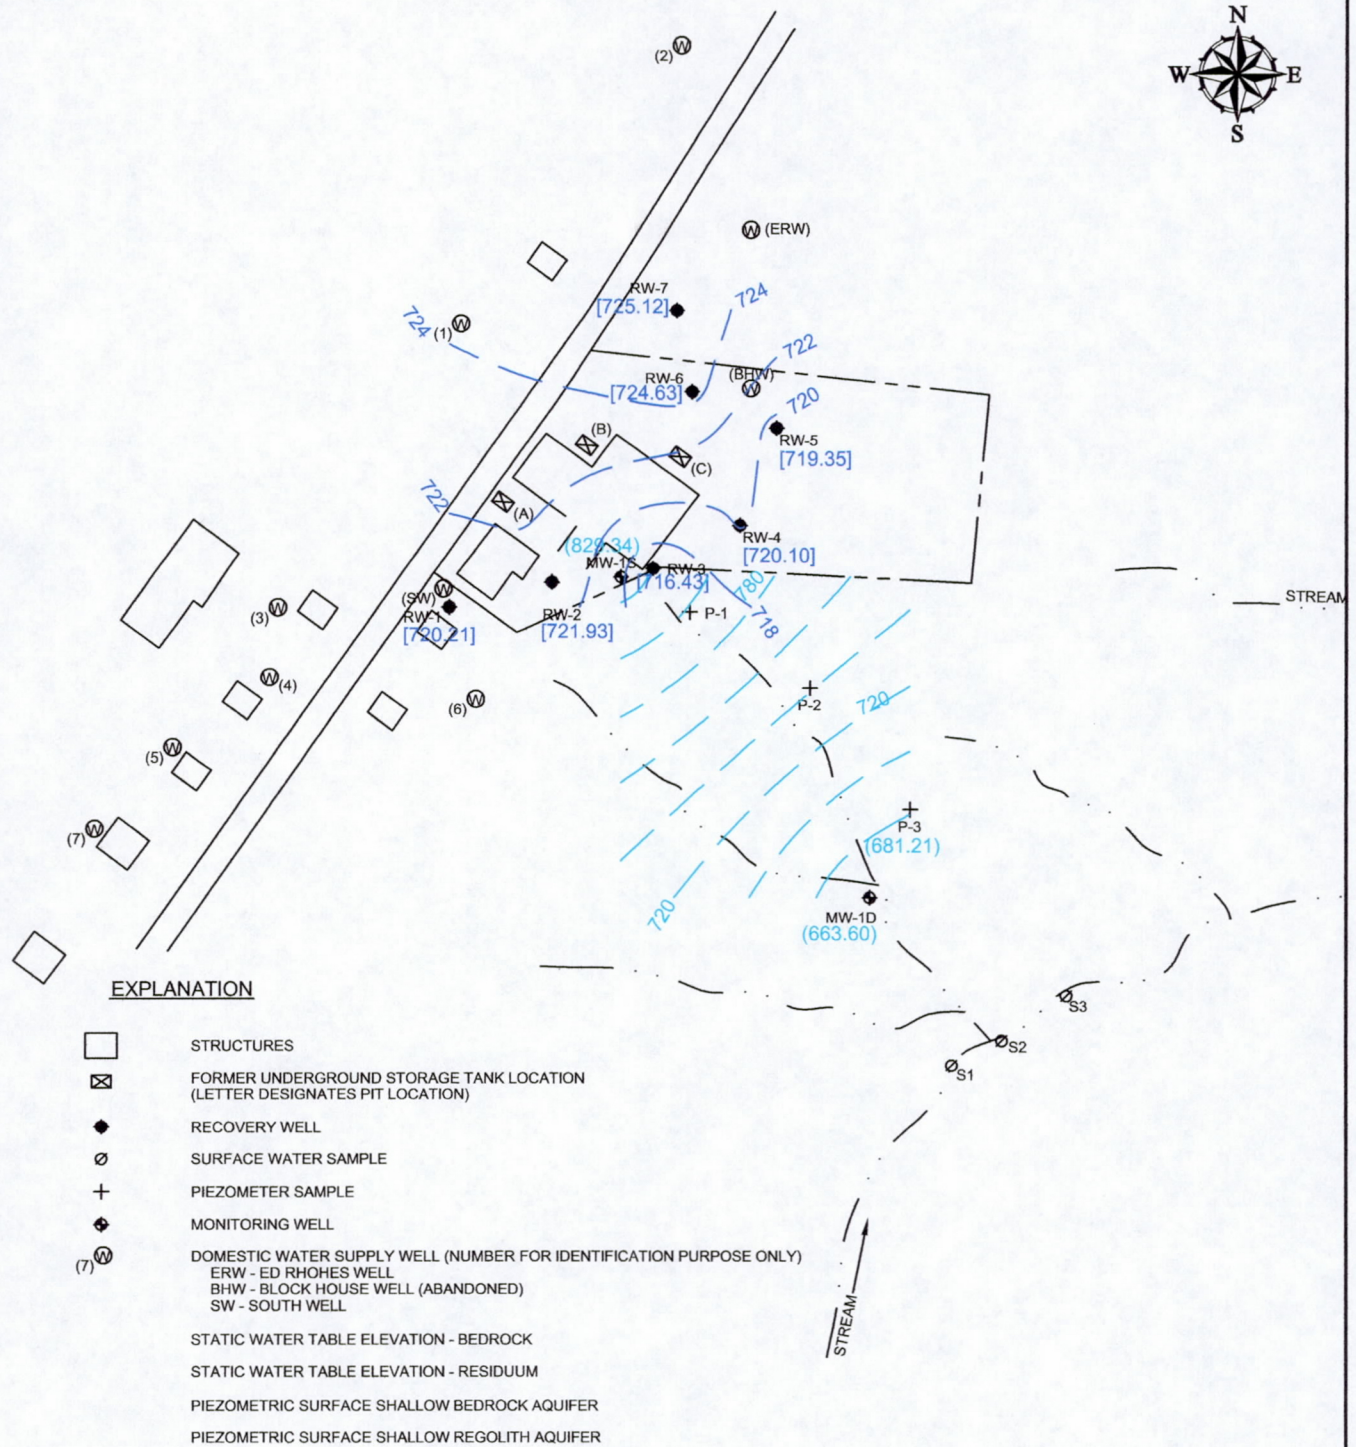
DESIGNED BY: JSE	DRAWN BY: SKJ	UPDATED BY: —	FIGURE NO:  8
APPROVED BY: JSE	PROJECT NO: 2719	DATE: 2/11/2011

The groundwater measurements collected on January 17, 2011 were used to prepare a groundwater surface contour map (Figure 8). The data shows groundwater in both the residuum and bedrock are moving generally to the southeast toward the stream. The water level data are

**GROUNDWATER FLOW MAP  
JANUARY 18, 2011**

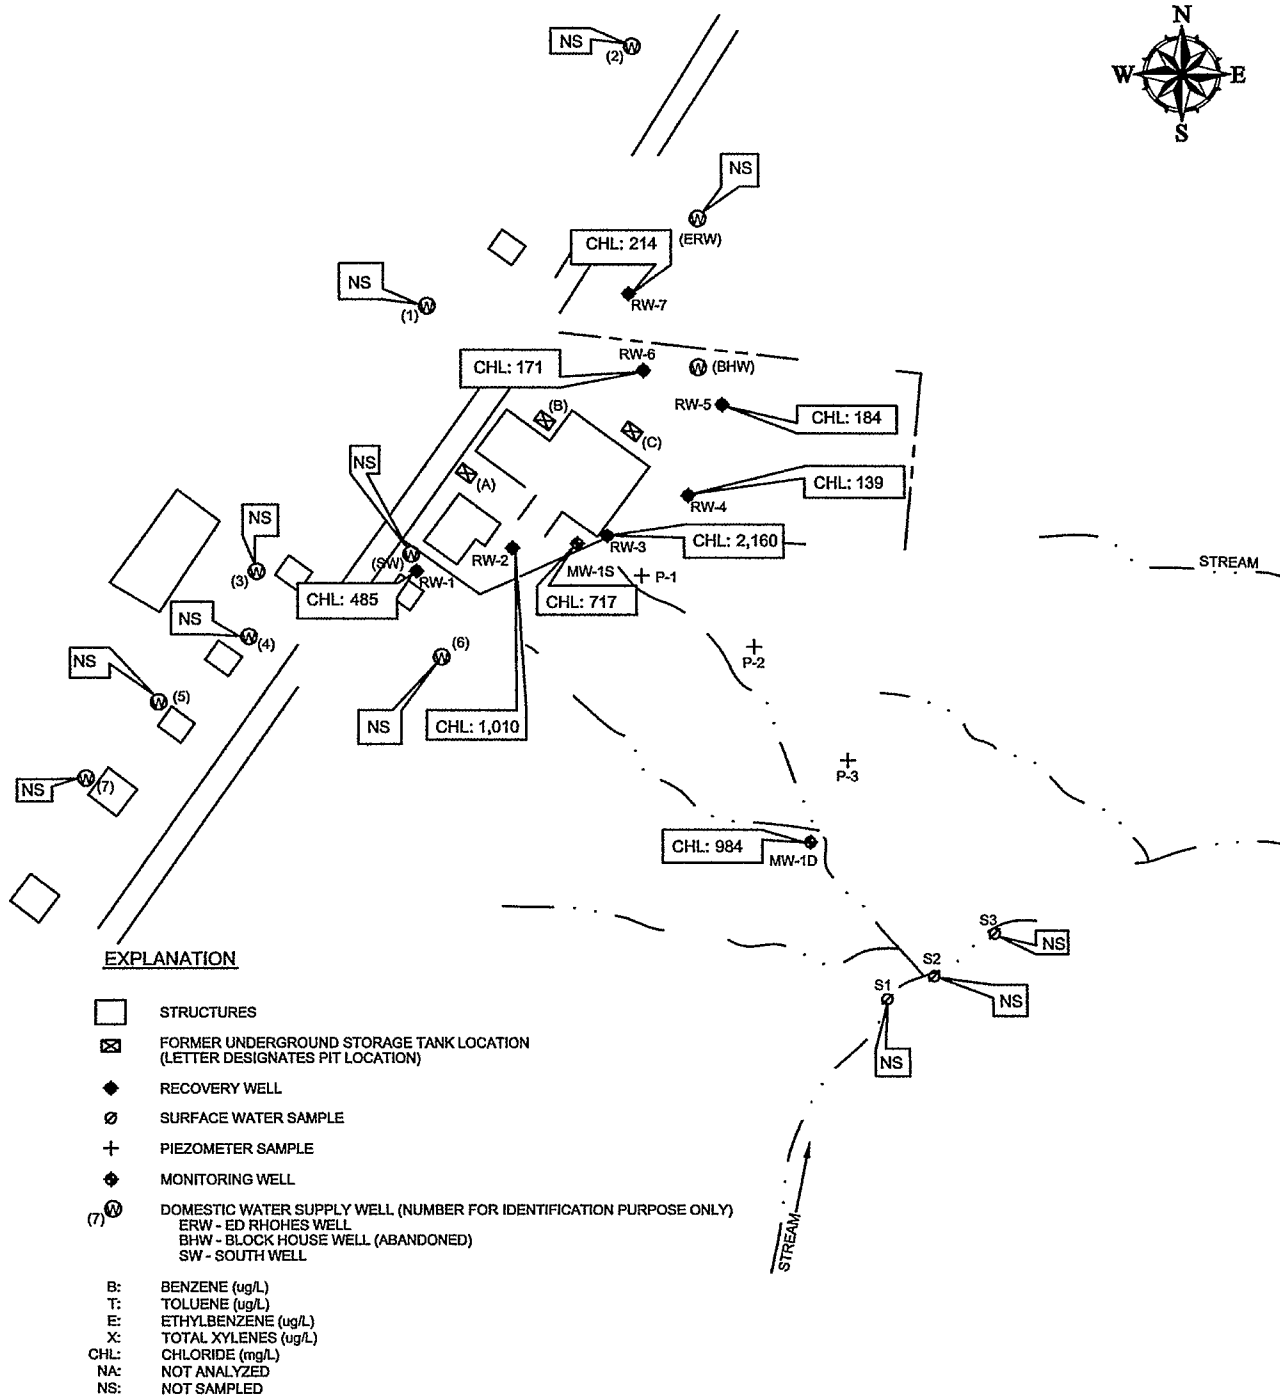
Based on the data collected during the January 2011 sampling event, chloride is concentrated in the area immediately behind (east-southeast of) the plant (MW-1S and RW-3) and along a line extending to the southeast toward the stream (MW-1D). A diffuse plume of chloride extends to the north, southwest, and west of the plant. Groundwater chloride results from the January 2011 sampling event are plotted on Figure 9.

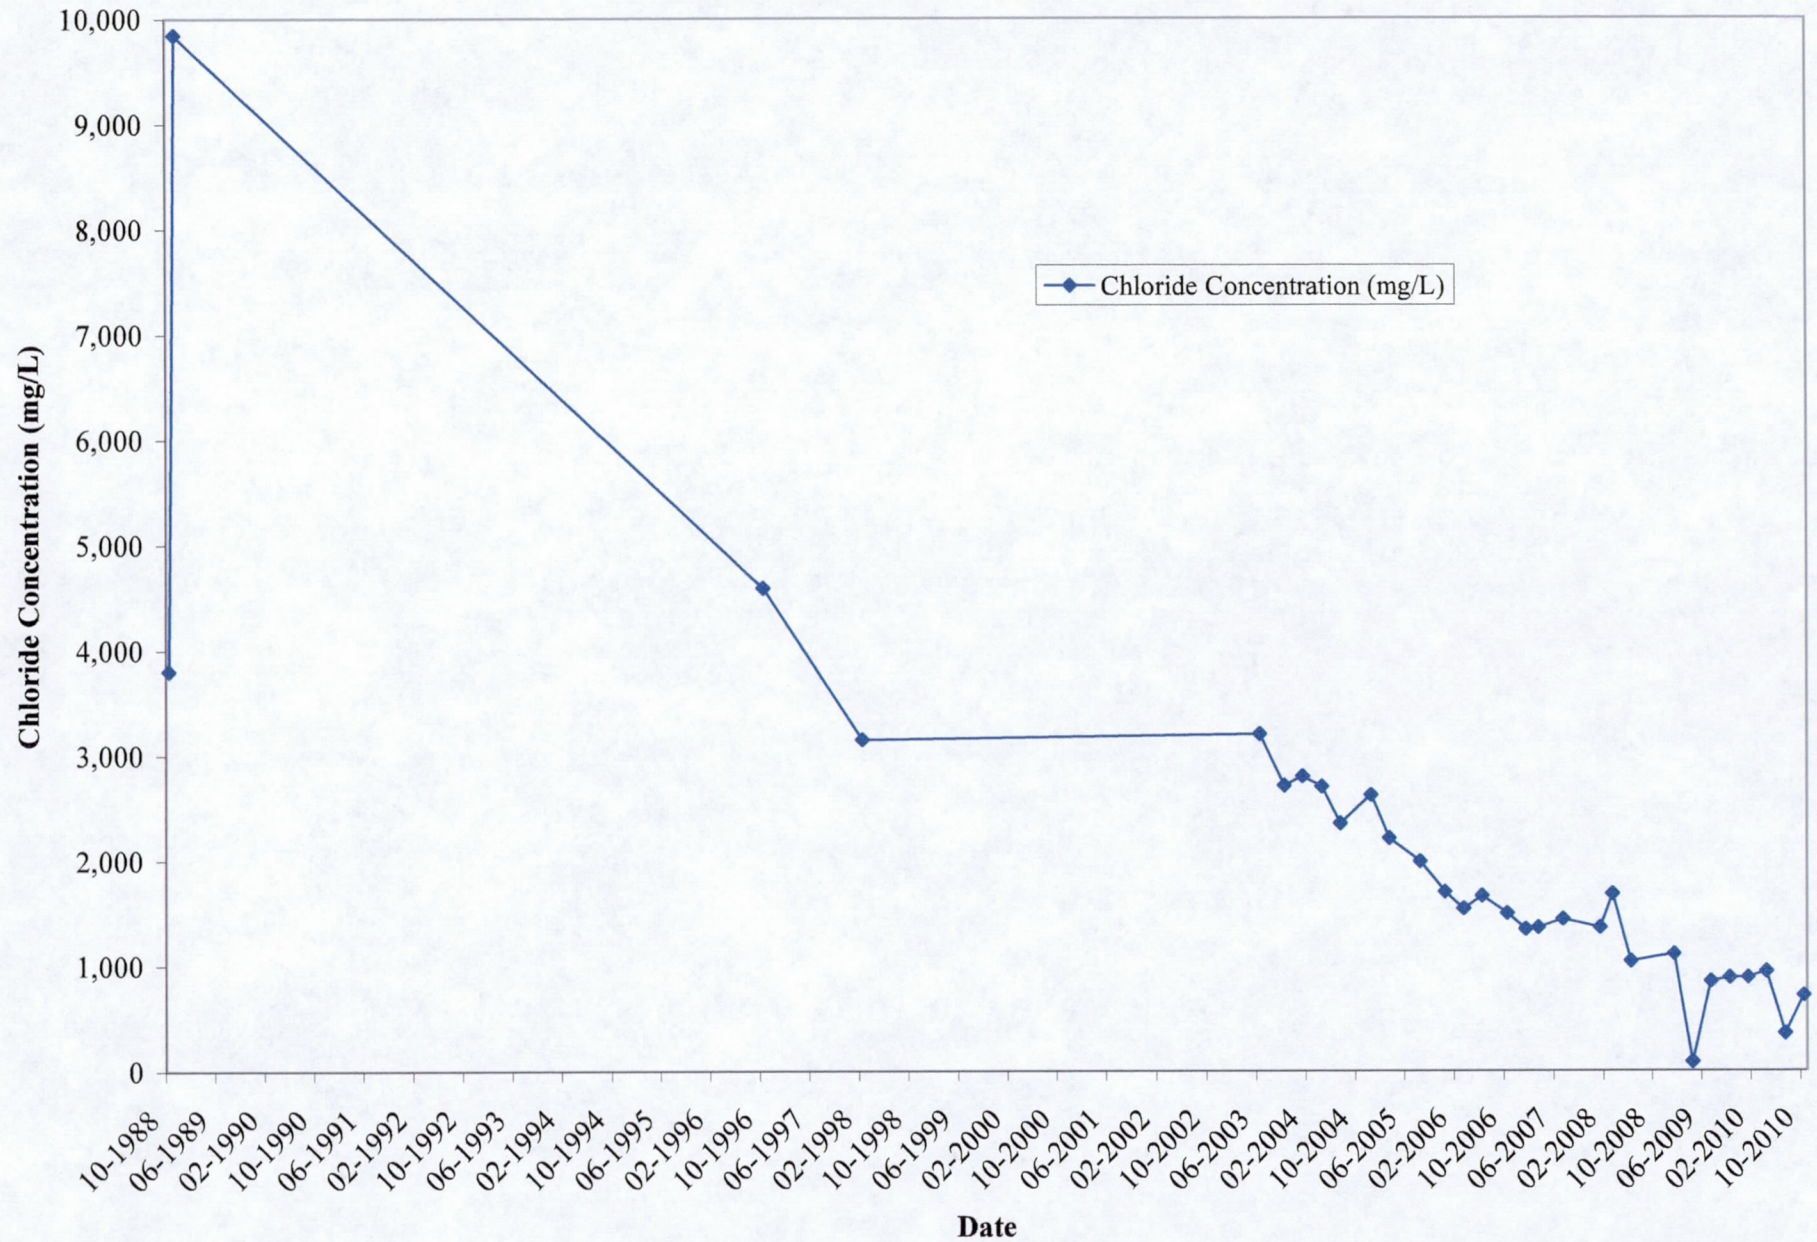
MW-1S Chloride Concentration Over Time

Review of historical chloride concentrations from the site monitoring and recovery wells in Table 4 reveals the following general trends. MW-1S has shown an obvious decreasing trend, indicating a reduction in the core of the chloride plume. Wells RW-4, RW-5, and RW-6 show possible decreasing concentrations with gradual negative sloping trends and wells MW-1D, RW-1, RW-2, RW-6, and RW-7 show generally stable concentrations with no easily-recognizable trend.
